Cleveland I-90 Inner Belt Bridge Vs Minneapolis I-35W Bridge

Authors: Ian Conant, Amy Kalabon, Errol Scholtz, and Tyra Studmire

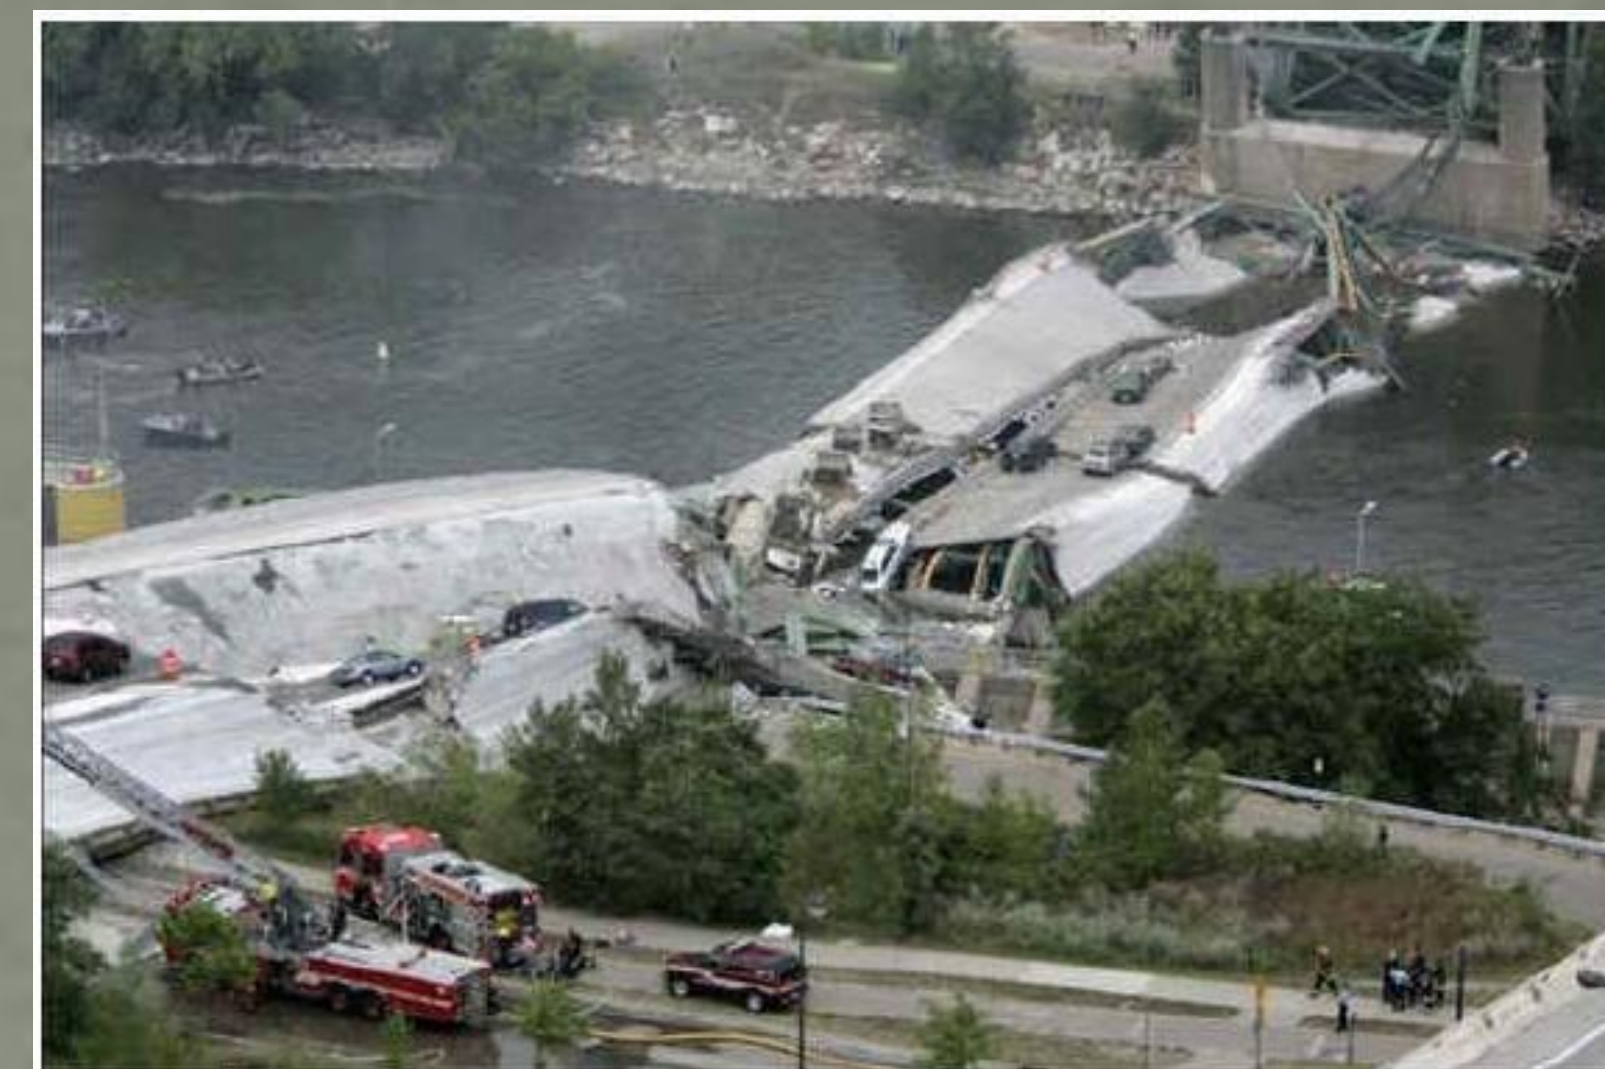
The I-35W bridge was designed as a non-redundant structure, meaning that if any member fails, the entire bridge can collapse. Unfortunately the bridge collapsed in 2007 across the Mississippi River during rush hour as shown in figure 1. The bridge was about 40 years old. What fate does that leave for the almost 50 year old I-90 Inner Belt Bridge?

Fig. 1: The collapsed Minneapolis I-35W Bridge

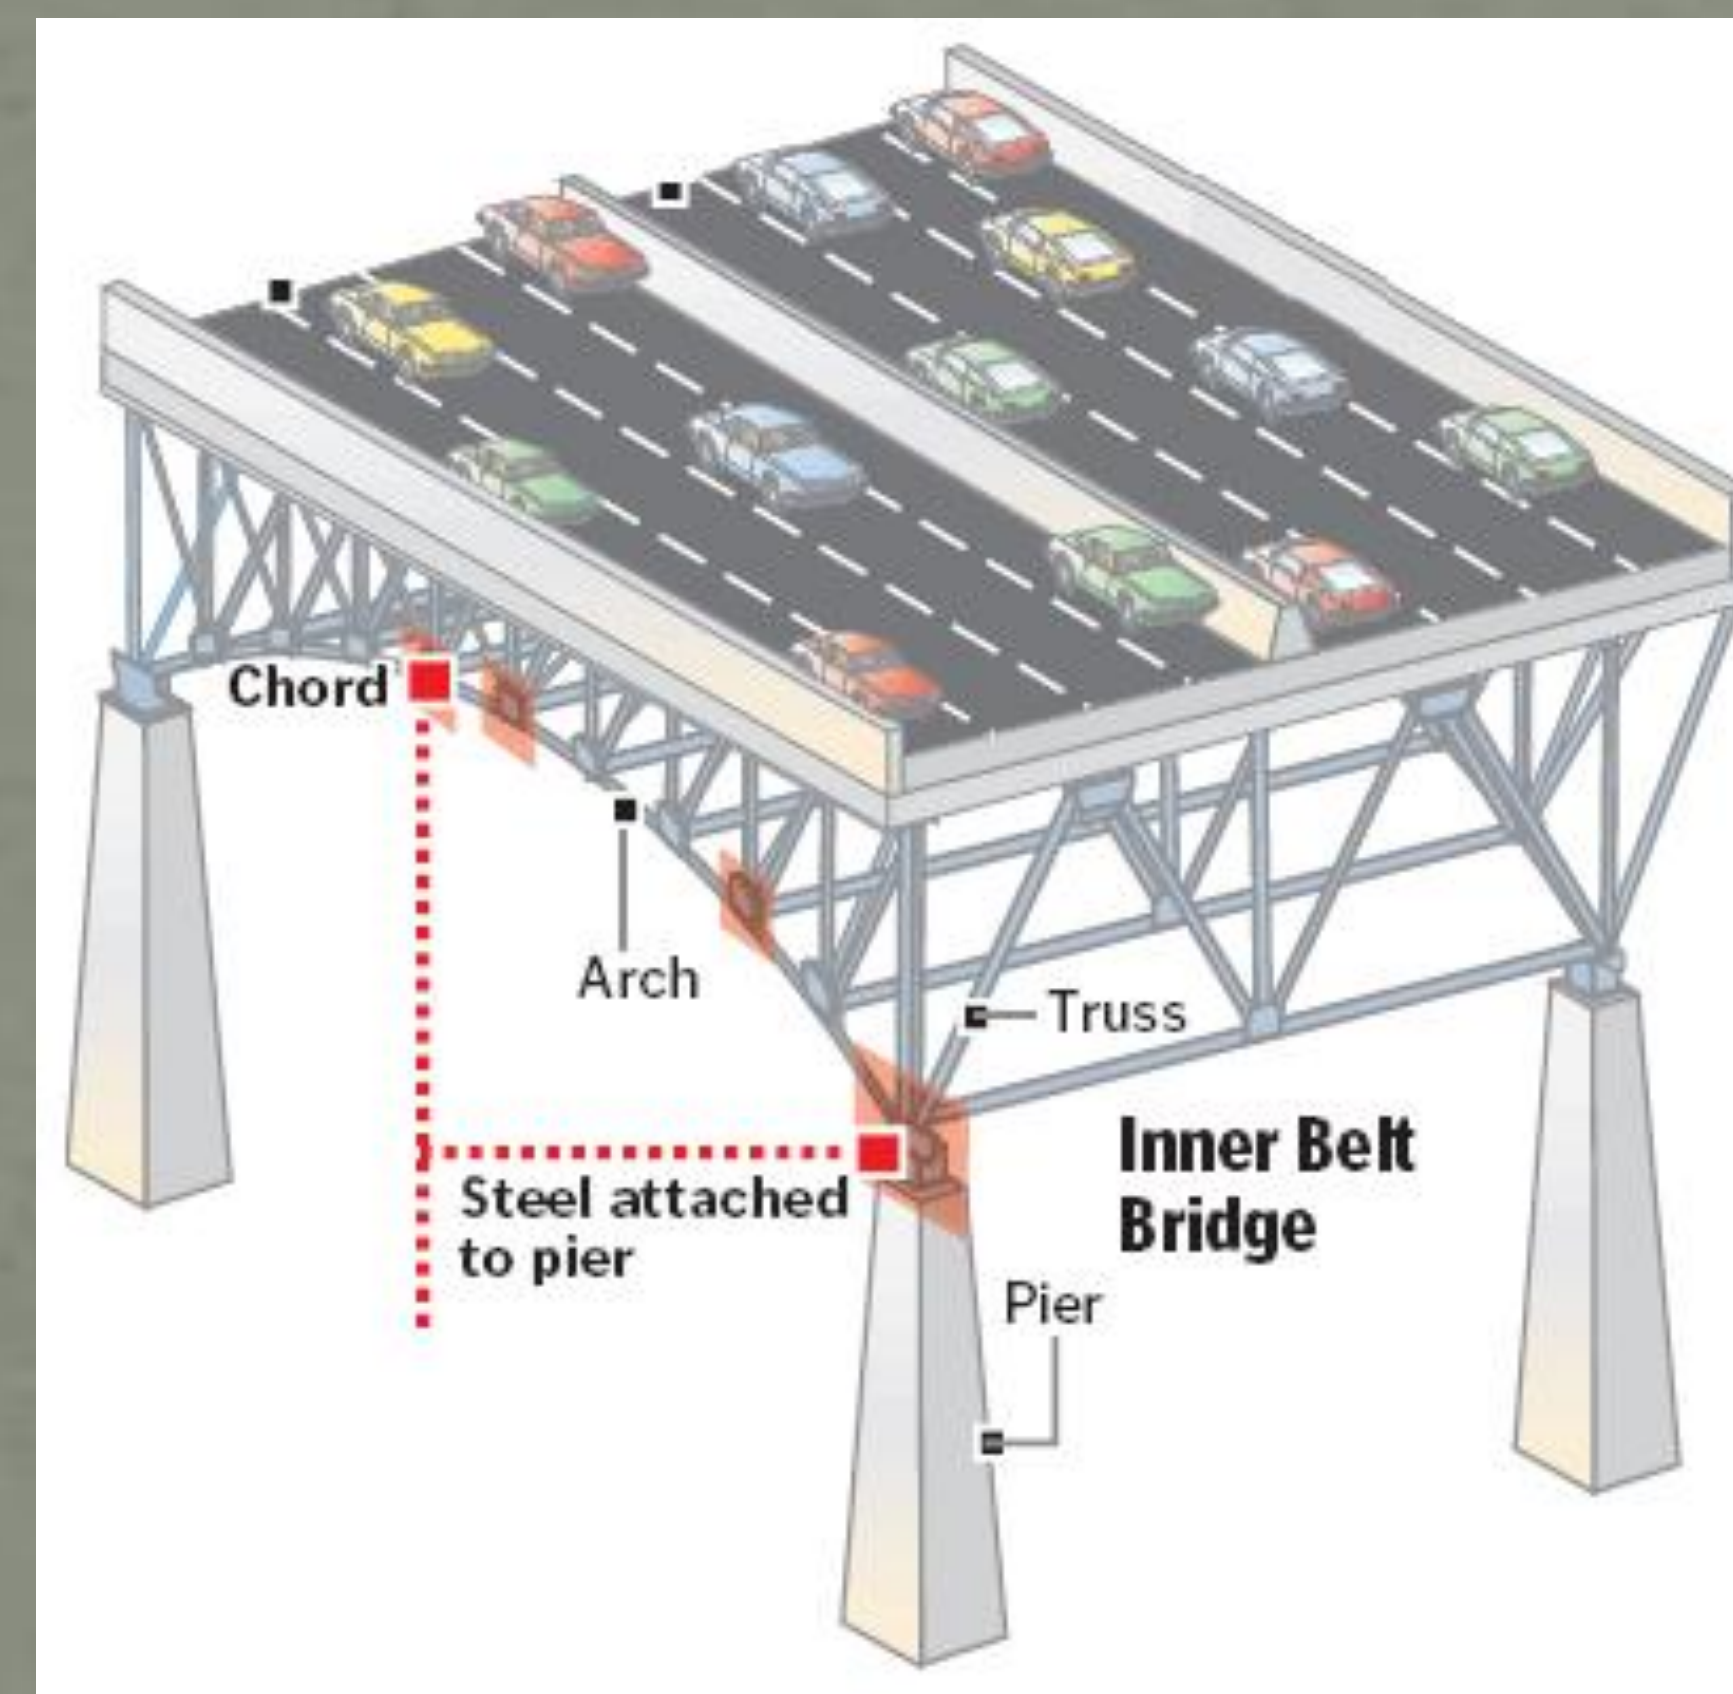
After an inspection, ODOT (Ohio Department of Transportation) discovered corroded steel chords. **Chords** are found where the truss meets the arch as represented in figure 3. They rated 19% of lower chords "very bad" with large deformation or holes in them, and 47% were rated "bad." They found corrosion on three dozen gusset plates, and two gusset plates had buckled about an inch. **Corrosion** is the deterioration of a material, normally a metal that results from a reaction with its environment. In the case of the I-90 bridge, the Cuyahoga river below and the required amount of salt dumped on the bridge every winter raises the rate of corrosion.

Fig. 3: Section of I-90 Bridge
